Manhole Inspection Summary

Manhole # S21KK_010MH

Location Address: **1846 NORTH AVE**

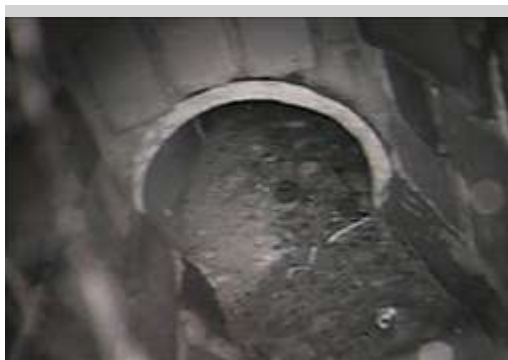
I6 OF THE ABANDONED LINE

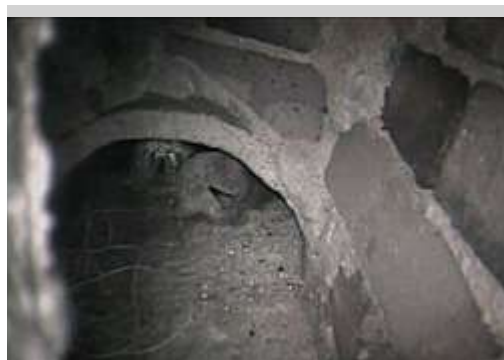
O12 OF THE ABANDONED LINE

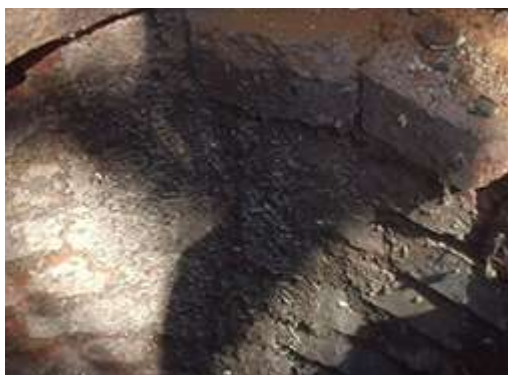
Defect 4

Infiltration: ☐ None ☐ Joint ☐ Cracks ☐ Mortar ☐ Roots ☒ **Wall**

INFILTRATION OF CORBEL WALL

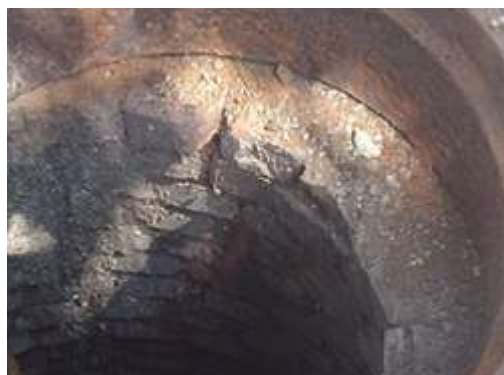
Defect 3

Condition: ☐ Sound ☐ Cracked ☐ Root Intrusion ☒ **Loose Brick** ☐ Deteriorated

LOOSE BRICKS IN THE CHIMNEY

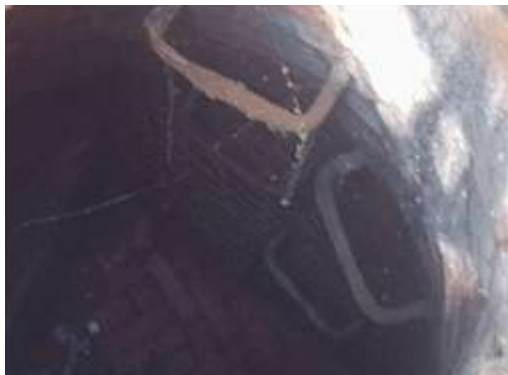
Defect 2

Steps Count: **6** Missing: **0** ☒ **Corroded**

CORRODED STEPS

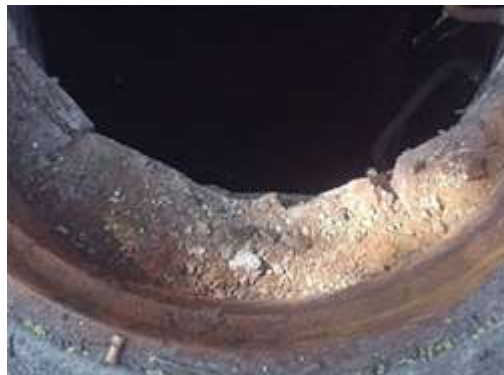
Defect 1

Frame Offset: **6** (in.) Condition: ☒ Sound ☐ Cracked ☐ Leaks

FRAME OFFSET

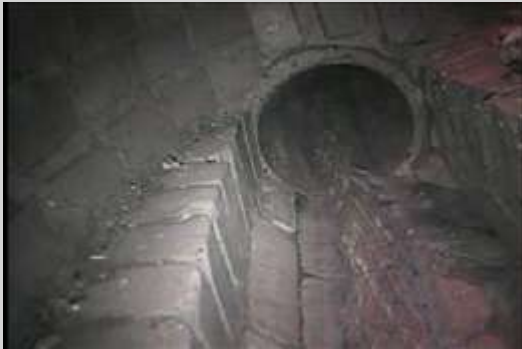
12 O'Clock Outflow

8 in. Circular Gravity Sewer
Pipe Out @ 12 O'Clock

Pipe Height: **7.2** (in.) Rod and Bar (Angled)
Pipe Material: **Clay** ☐ Pipe Lined
Invert Depth: **11.40** (ft.) Flow Characteristics: **Slow**
Deposits: ☒ None ☐ Mud ☐ Sludge ☐ Debris ☐ Grease
Silt Depth: (in.) Deposits Extent:
Infiltration: **None** Pipe Seal Cond: **Sound**

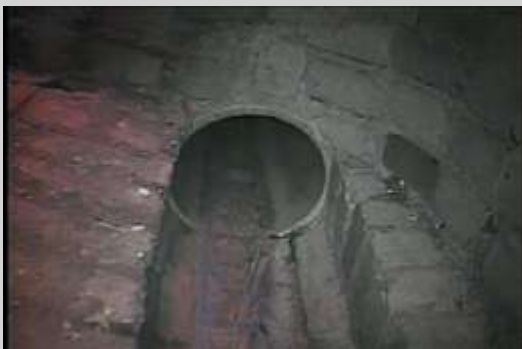
6 O'Clock Inflow

8 in. Circular Gravity Sewer
Pipe In @ 6 O'Clock

Pipe Height: **8.4** (in.) Rod and Bar (Angled)
Pipe Material: **Clay** ☐ Pipe Lined
Invert Depth: **11.32** (ft.) Flow Characteristics: **Slow**
Deposits: ☒ None ☐ Mud ☐ Sludge ☐ Debris ☐ Grease
Silt Depth: (in.) Deposits Extent:
Infiltration: **None** Pipe Seal Cond: **Sound**
